SERVICE ENGINEERING BULLETIN SB2135.1

Valve Face Burning

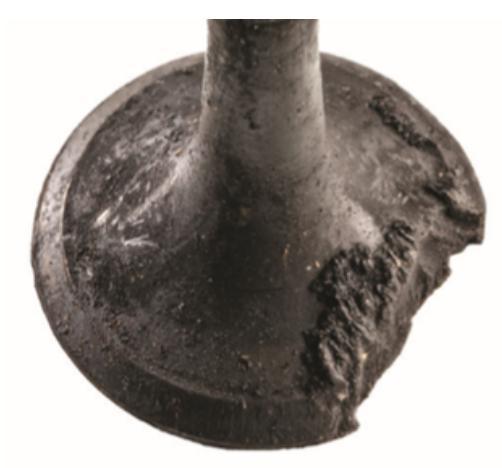
1.Exhaust Valve Guttering - Fig. 1

This refers to exhaust valve burn out that is local; usually in one location or but possibly appears in other areas. The burn out will form a deep channel in the valve head. Radial cracks may develop, or pieces may even break away, depending on the design of the valve head and if left running too long.

With both austenitic valve heads and hard-faced valves (stellite etc.) the likely causes are:

a. Lack of tappet clearance results in light seating and carbon build up on the seating face. Both factors lead to destruction of the thermal heat path outlet from the valve face through the valve seat to the coolant. This causes a considerable rise in valve head temperature, particularly in the valve face area. Eventually, the conditions exceed the material's resistance to hot corrosion or burning. As the localised gas leak increases, so does the torching effect through the gap, eventually producing the characteristic gutter.

b. High carbon deposit build up between the valve face and seat caused by over-rich combustion, excessive oil consumption, etc. This also destroys the thermal path and ultimately leads to valve burn out. However, partial breakaway of these deposits can accelerate failure by causing localised gas leakage.

c. Nickel based alloys have a high hot corrosion resistance but are weak in the erosion phase when torching occurs. Therefore, their rare but characteristic mode of failure is nearly always a deep gutter due to a local gas leak.

d. Pre-ignition due to incorrect air/fuel ratio,

inaccurate timing or incandescent hot spots on the valve head periphery. These produce high gas loads and localised temperatures, which sometimes lead to guttering. In some engines, piston failure occurs before the valve shows signs of distress.

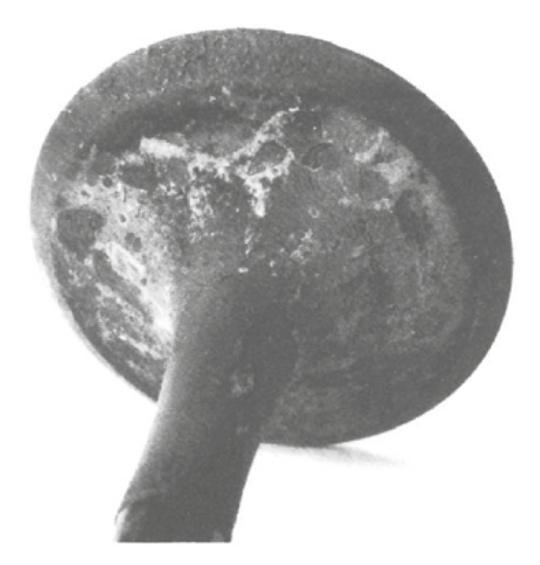
3.Exhaust Valve Broad-Face Burning - Fig. 2

This applies to burnt valves where there is no deep gutter or local channelling. The affected area extends for a distance around the valve face. The valve material burns or corrodes away more or less evenly. This allows gas to escape through a very narrow gap over a wide area, with resultant loss of performance. Non-hard faced valves are more prone to this, the likely causes of this type of failure are:

a. Misalignment between the valve head and seat brought about by –

- Incorrect alignment of the valve guide to seat
- Inherent valve bridge weakness
- Engine overload
- Valve head distortion due to poor cooling etc.

b. Valve springs too weak.

c. Valve seat insert movement.
